SUBJECT: April 2015 Inspection Report for the former Cornell Dubilier Electronics (CDE) Superfund Site, South Plainfield, New Jersey

LATA Project # 11266
Contract # W912DQ-09-D-3003,
Task Order # 0011

DATE: May 1, 2015

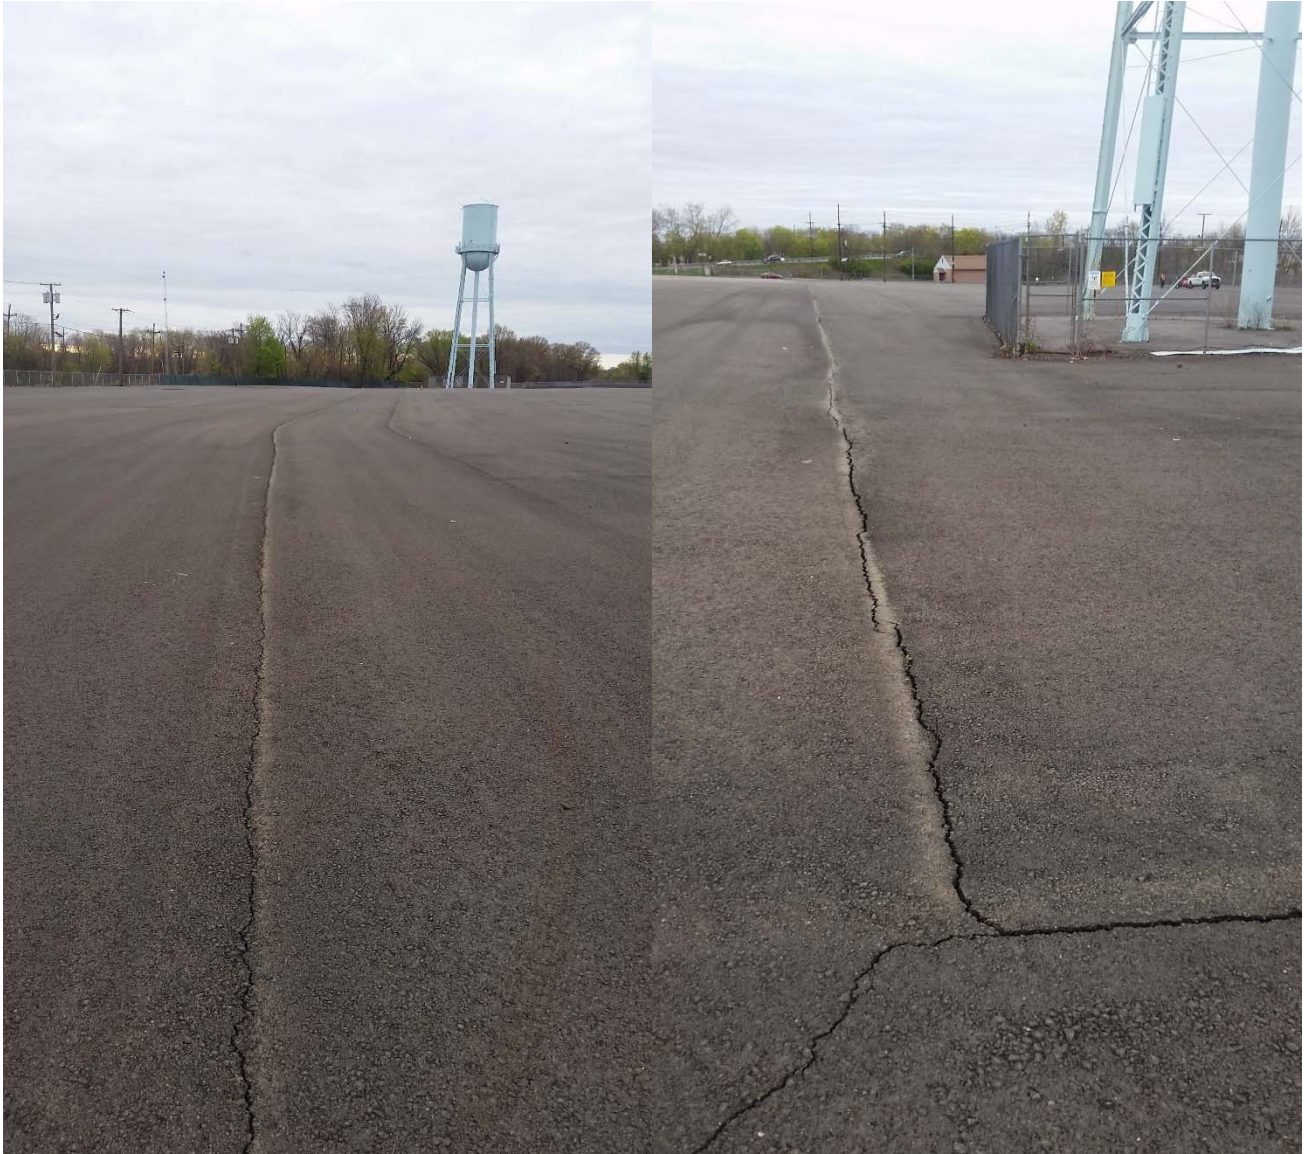
Pavement cracks prior to repairs. This crack was located on the north end of the property. The picture on the left shows the western end of the crack. The picture on the right shows the eastern of the same crack.

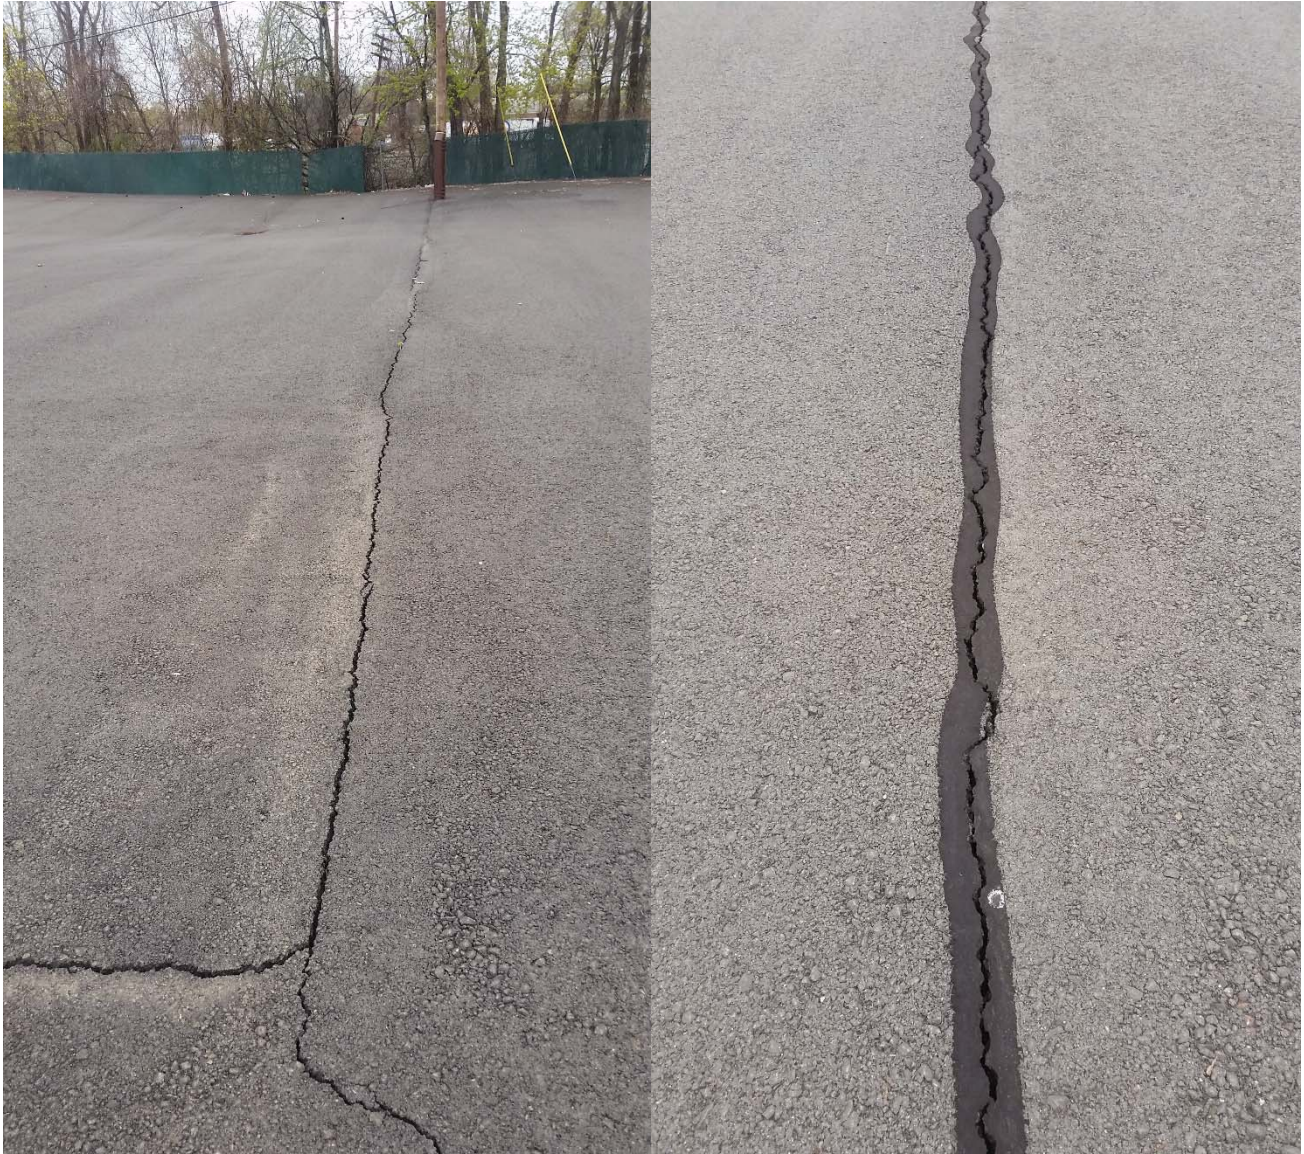
Pavement cracks prior to repairs. The crack on the left was located on the north end of the property, east of the water tower. The crack on the right was located near the south end of the property.

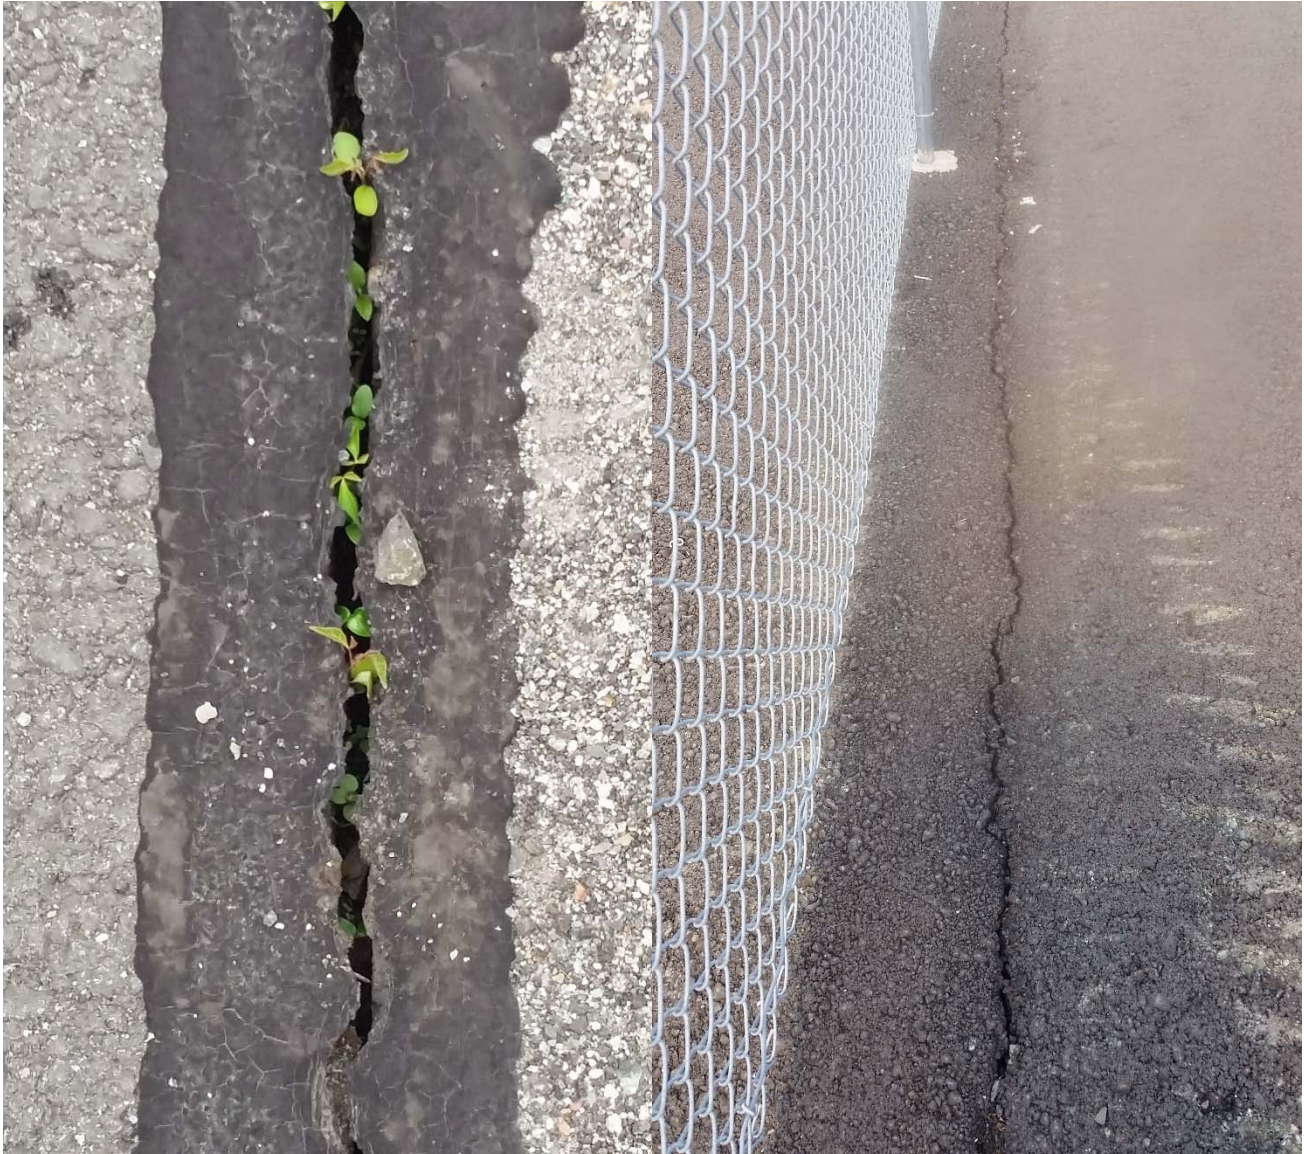
Pavement cracks prior to repairs. The crack on the left was located near the south end of the property. The crack on the right was located outside the fence around the southern side of the detention basins.

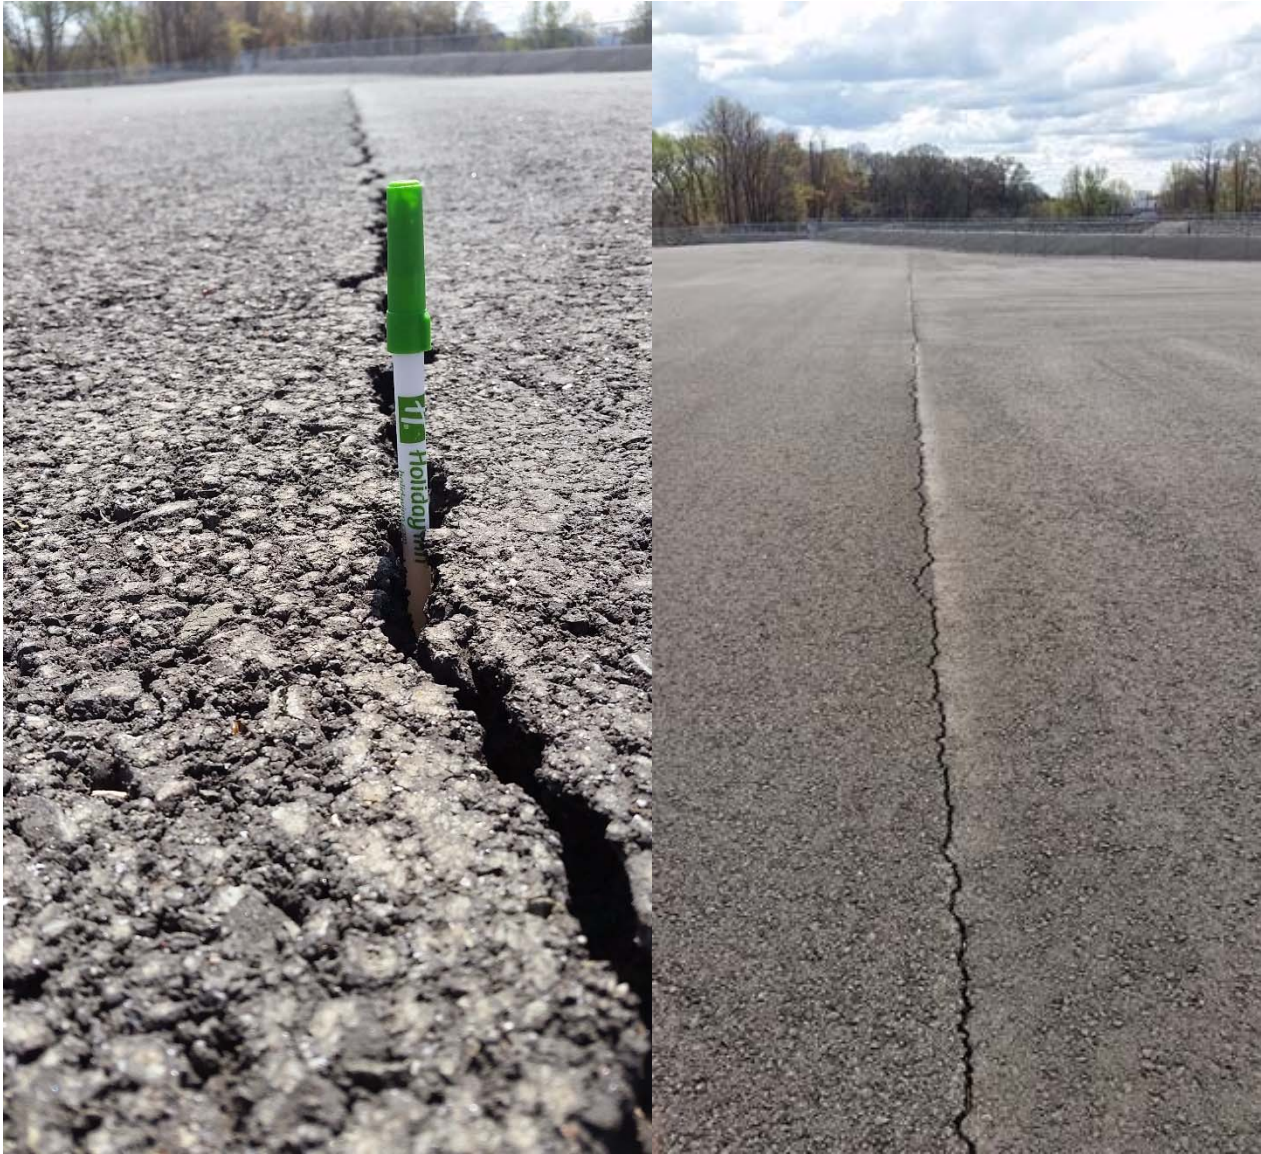
Pavement crack prior to repairs. This crack was located west of the detention basins.
